PRODUCTION CHANGES IN CTC4 AND CTC4A

Circuit Diagram for Chassis Numbers CTC4, CTC4A

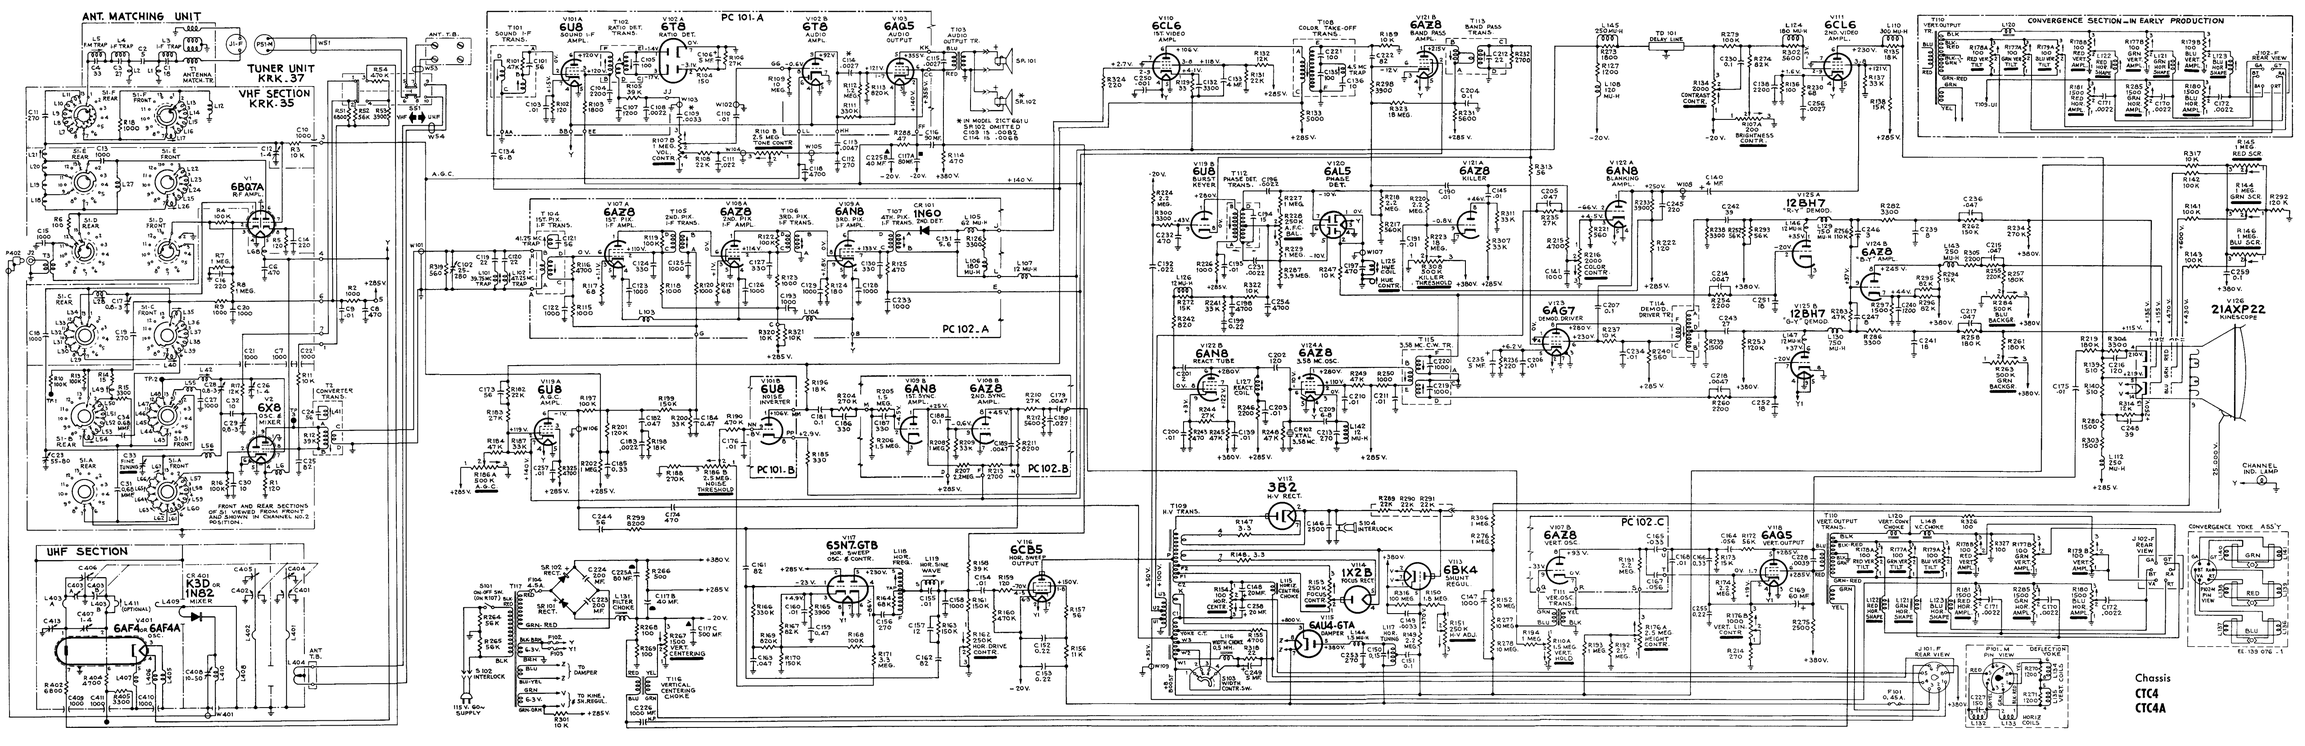
In some receivers, a .082 mf. capacitor (C142) was connected from the green screen control (R144-2) to ground.
In some receivers, a .082 mf. capacitor (C143) was connected from the red screen control (R145-2) to ground.
In some receivers, a .082 mf. capacitor (C144) was connected from the blue screen control (R146-2) to ground.
In some receivers, C148 across terminals 1 and 2 of R154, horizontal centering control, was 10 mf.
In some receivers, a 10 mf. capacitor (C148A) was connected across terminals of 1 and 3 of R154, horizontal centering control.
In some receivers, C166, at terminal U of PC102, was connected to ground.
In some receivers, C175, at pin 5 of V118, was .039 mf.
In some receivers, C198, in grid circuit of V122B, was .01 mf.
In some receivers, C215, in plate circuit of V124B, was .01 mf.
In some receivers, C217, in plate circuit of V125B, was .01 mf.
In some receivers, C236, in plate circuit of V125A, was .01 mf.

In some receivers, C240, at pin 7 of V124B, was 270 mmf.
In some receivers, C243, at terminal D of T114, was 39 mmf.
In some receivers, C246, at pin 9 of V124B, was 2.0 mmf.
In some receivers, C247 was 18 mmf. and was connected between the junction of R305/R255 and ground.
In some receivers, C248, was .0012 mf., and was connected from the junction of L112/R314 to L111.
In some receivers, C254, in grid circuit of V122B, was omitted.
In some receivers, C255, at pin 2 of V118, was omitted.
In some receivers, C256, at pin 1 of V111, was omitted.
In some receivers, C257, at pin 3 of V119A, was omitted.
In some receivers, C258 across terminals 2 and 3 of R154, horizontal centering control, was omitted.
In some receivers, C259, between R146-3 and +385 volt bus, was omitted.
In some receivers, a 62 microhenry coil (L111) was connected between C248 and C240 at pin 7 of V124B.
In some receivers, a 1.0 MH coil (L128) was connected from pin 9 of V124B to the junction of R283 and R256.

In some receivers, L129, at pin 1 of V125A, was 1.7 MH.
In some receivers, L143, at pin 8 of V124B, was 1.7 MH.
In some receivers, L148, at R177B-3, was omitted and R177B-3, R178B-3 and R179B-3 were connected to L120.
In some receivers, R118, at pin 2 of V107A, was 10,000 ohms.
In some receivers, R123, at pin 2 of V108A, was 10,000 ohms.
In some receivers, R144, R145 and R146 (screen controls) were 500,000 ohms.
In some receivers, R203, a 3.3 megohm resistor, was connected between R186, noise threshold control and the junction of R199, C182, R201 and R197.
In some receivers, R230, at pin 1 of V111, was omitted.
In some receivers, R231, at terminal A of T113, was 10,000 ohms.
In some receivers, R232, across terminals C and D of T113, was 2,200 ohms.
In some receivers, R234, at pins 2-9 of V110, was omitted.
In some receivers, R256, at pin 9 of V124B, was 120,000 ohms.
In some receivers, R259, in plate circuit of V125B, was 56,000 ohms.

In some receivers, R276, in lead to V126-9 (kinescope), was 470,000 ohms.
In some receivers, 56,000 ohm resistor (R281) was connected in parallel with R259 at V125B plate circuit.
In some receivers, R283, at pin 9 of V124B, was 56,000 ohms.
In some receivers, R292, at R146-1, was 56,000 ohms, 2 watts.
In some receivers, R297, at pin 7 of V124B, was 2700 ohms, 2 watts.
In some receivers, R306, in lead to V126-9 (kinescope), was 470,000 ohms.
In some receivers, a 470 ohm resistor (R312) was connected between pin 6 of V116 and −20 volt bus.
In some receivers, R314, at pin 13 of kinescope, V126, was 470 ohms and was connected between the junction L112/C248 and the −285 volt bus.
In some receivers, a 180 ohm resistor (R315) was connected between the junction of C240/L111 and ground.
In some receivers, R319, at T104 input, was omitted.
In some receivers, R320 and R321, between terminal C of PC102 and −285 volt bus, were omitted.

In some receivers, R322, in grid circuit of V122B, was omitted.
In some receivers, R323, at terminal A of T113, was omitted.
In some receivers, R325, at pin 3 of V119A, was omitted and V119A-3 was connected to −285 Volts.
In some receivers, R326, at R179B, vertical amplitude control, was omitted.
In some receivers, R237, at R177B-3, was omitted.
In some receivers, terminal U1 of T109 was −70 volts.
In some receivers, V111-4 was connected to Y1 instead of Y.
In some receivers, V115 was a 6BL4.
In some receivers, V121B-2 was connected to terminal A of T113.
In some receivers, V125A pins 4 and 5 were connected to Y instead of Y1.
In some receivers, the blu/yel lead of T117 was not connected to +380 volts and the blu lead of T117 was grounded.
In some receivers, the convergence circuit was connected as shown in the small circuit shown at the upper right hand corner of the schematic diagram.
